Name Of Dam: GATEWOOD DAM

Location: PULASKI COUNTY, VIRGINIA

# PHASE I INSPECTION REPORT NATIONAL DAM SAFETY PROGRAM

NATIONAL DAM SAFETY PROGRAM  
PHASE I INSPECTION REPORT

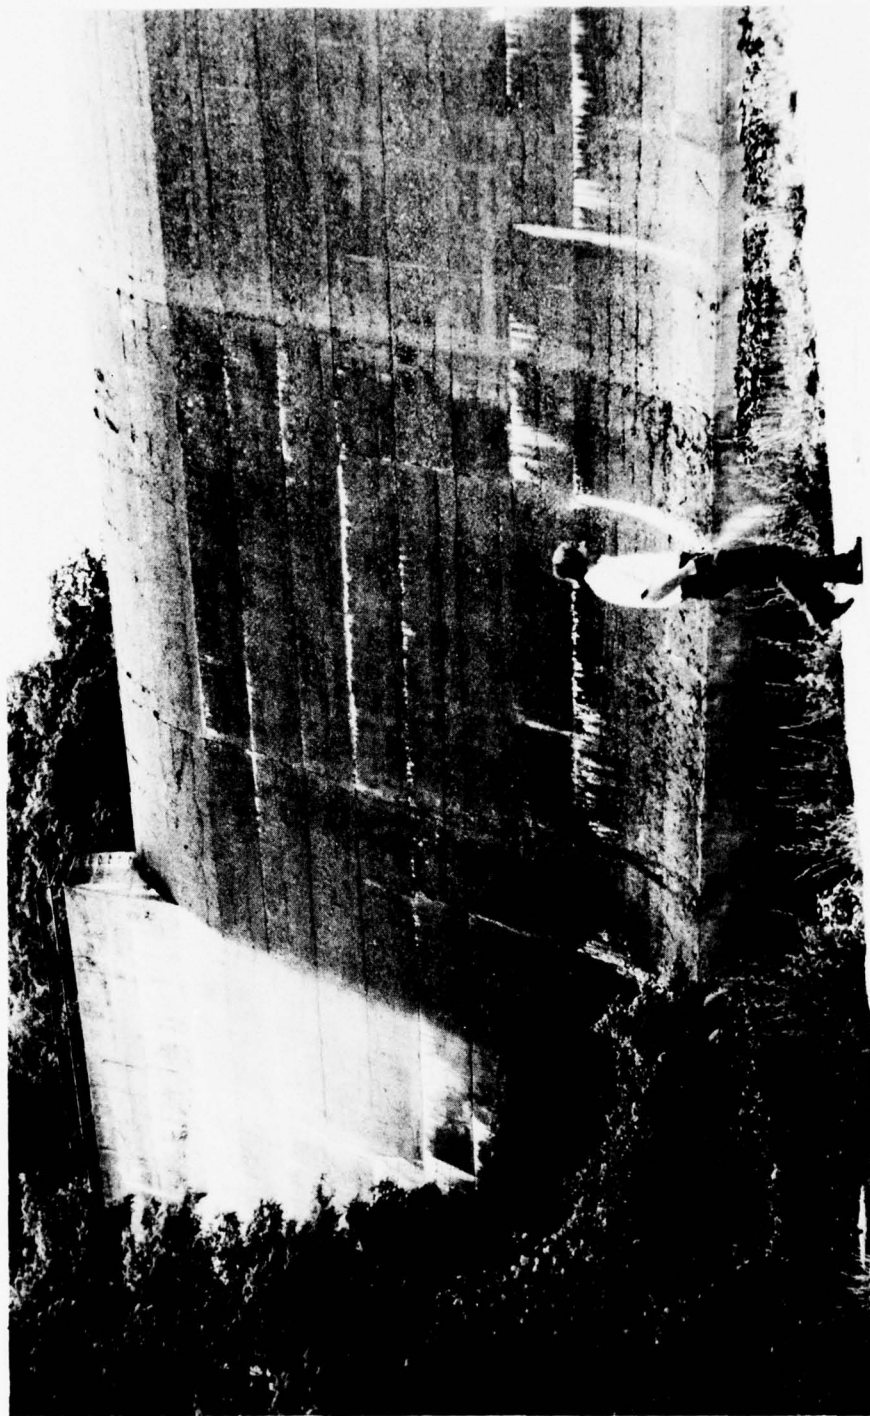
OVERVIEW OF GATEWOOD DAM

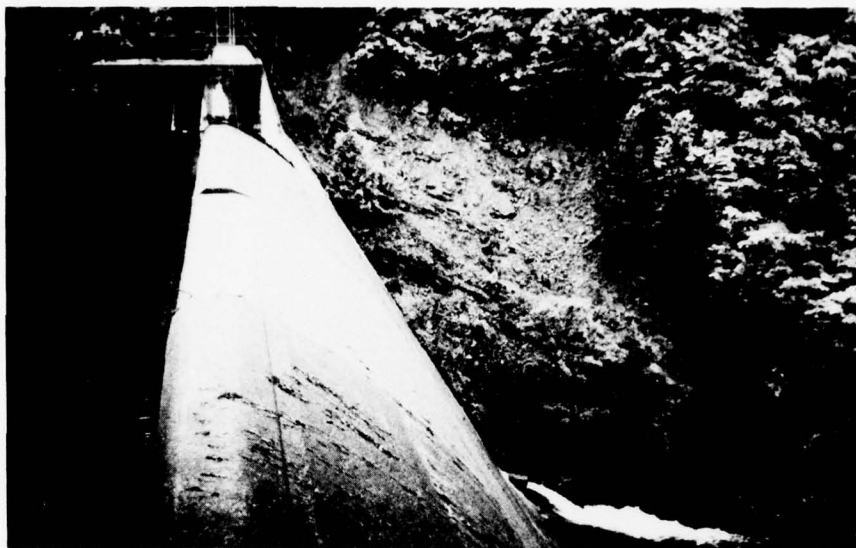
VIEW OF THE DAM CREST AND GATE TOWER

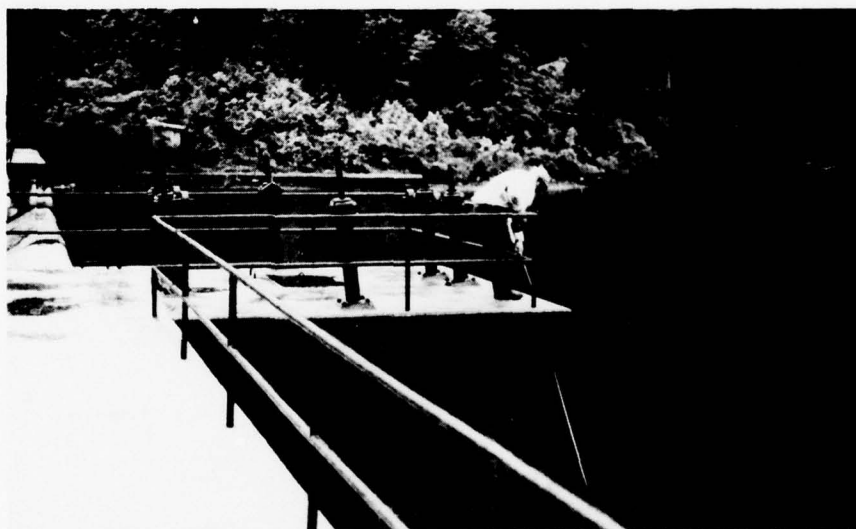
GATE TOWER AND OPERATING DECK

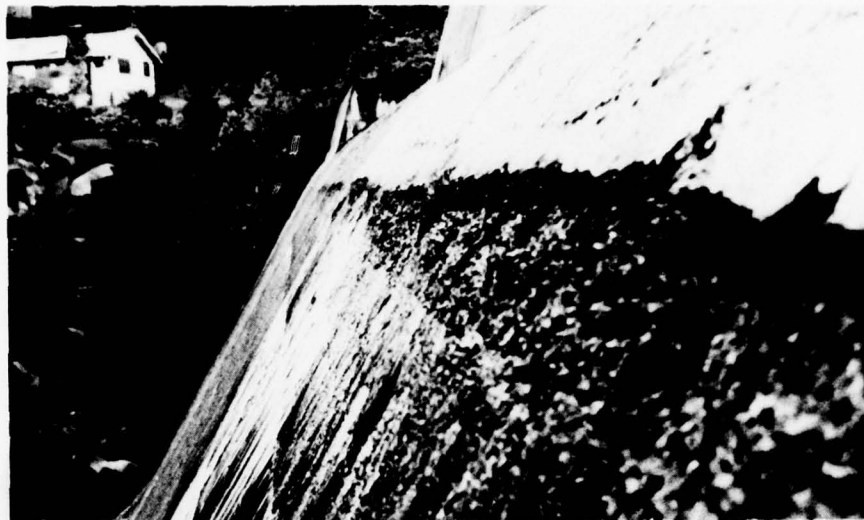
There were two areas of the dam structure which showed signs of wear and stress. The top of the third monolith section below the spillway crest, (approximate elevation 2150 feet) on the left side of the dam has developed some severe scaling which is several inches deep. There was no observed seepage from this area, but considerable staining of the concrete below it indicated that seepage may occur under other conditions. A picture of this area is in Appendix II. A transverse crack about 1/2 inch wide on the face of the dam has developed through three of the concrete lifts near the left end of the spillway. The crack occurs at a location where the vertical construction joints of the upper lifts were offset from the joints below

VIEW OF SEVERE DETERIORATION OF CONCRETE ON LEFT ABUTMENT

5. Deteriorated Concrete - As mentioned in the previous reports, there is considerable deterioration of the concrete surface in the third lift from the crest of the spillway. This deterioration begins immediately northeast of the normal spillway crest and extends all the way to the northeast abutment. The spalling reaches a maximum depth of approximately 5". This concrete was apparently of poor quality and has deteriorated due to weathering.

5. Grout the deteriorated concrete lift (3rd lift below spillway @ northeast end) and replace the deteriorated concrete surface with epoxy bonded cast-in-place concrete. The grouting should precede the resurfacing of the downstream face. The maximum repair area appears to be approximately 120' x 5'.

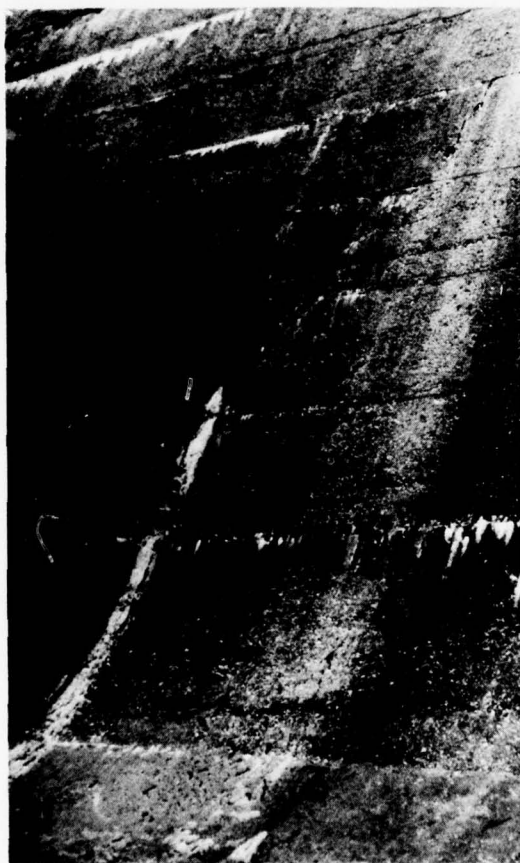
them. The crack starts at a vertical joint, runs diagonally upward across three lifts, and ends at the vertical construction joint of the upper lifts. No seepage was observed from the crack but stains on the concrete indicated that seepage has occurred in the past. The crack is shown in Appendix II.

TRANSVERSE CRACK ON THE FACE  
OF THE DAM

VISUAL EXAMINATION OF	OBSERVATIONS	REMARKS OR RECOMMENDATIONS
STRUCTURAL CRACKING	<p>A transverse crack running through three concrete lifts was observed below the left end of the spillway. The crack starts five lifts below the crest at a level where the vertical construction joint between monoliths was offset. It then runs downward and intersects another vertical joint.</p>	
VERTICAL AND HORIZONTAL ALIGNMENT	<p>All concrete surfaces appeared straight or built to the proper contour. No bulging or sagging was observed.</p>	
MONOLITH JOINTS	<p>Efflorescent deposits on face of dam indicates seepage above joints. Because of wet weather conditions, it could not be determined if any seepage was actually coming through the joints. The worst area was near the left side of the dam where deterioration of the concrete is also visible, but signs of seepage are also visible at the base of the dam for the entire length.</p>
